CONTINUING ELIGIBILITY INSPECTION (CEI) REPORT

FOR HURRICANE & SHORE PROTECTION PROJECTS

- 1. Project Name: Matafao Shore Protection Project
- 2. Date of Inspection: April 10, 2002

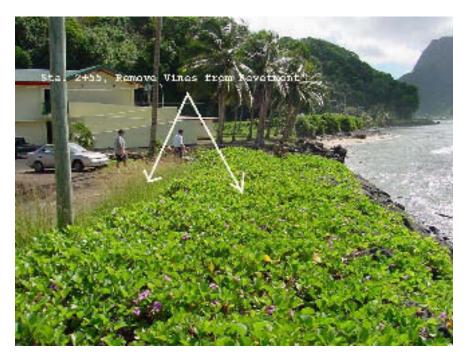
a. Sta. 2+55, Remove vines from crest of the structure.

The focus of the maintenance required should be directed at vegetation control. Removal or herbicides are recommended in lieu of cutting.

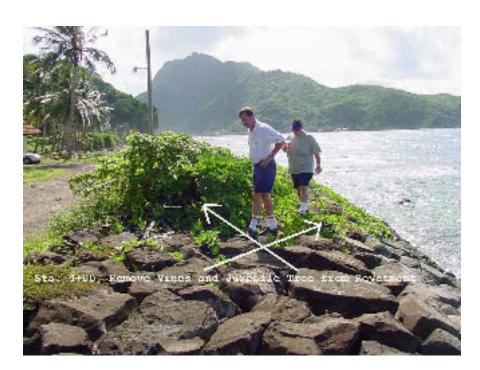
b. Sta. 4+05, Remove vines and trees from revetment, unable to inspect.

c. Sta. 4+10, 1 cracked armor stone midway down the sideslope, no problems noted.

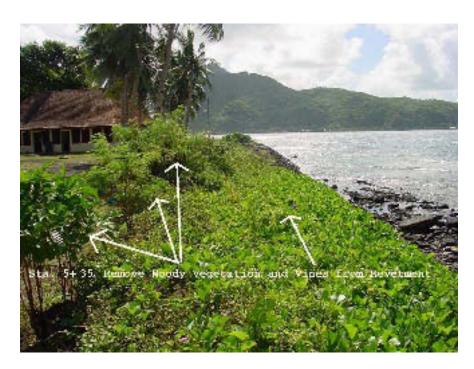
e. Sta. 5+35, Remove woody vegetation and vines from revetment, unable to inspect.

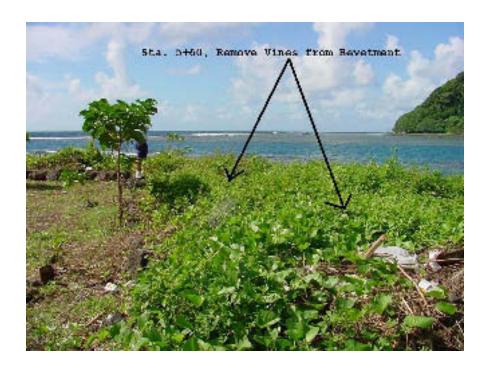
f. Sta. 5+60, Remove woody vegetation and vines from revetment, unable to inspect.

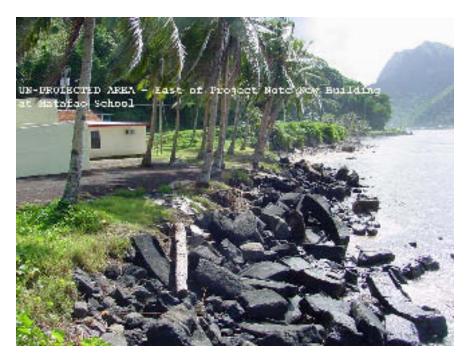
Adjacent too and East of Existing Project, Note New School Building in the background.
